Case Study

Neighbour Dispute

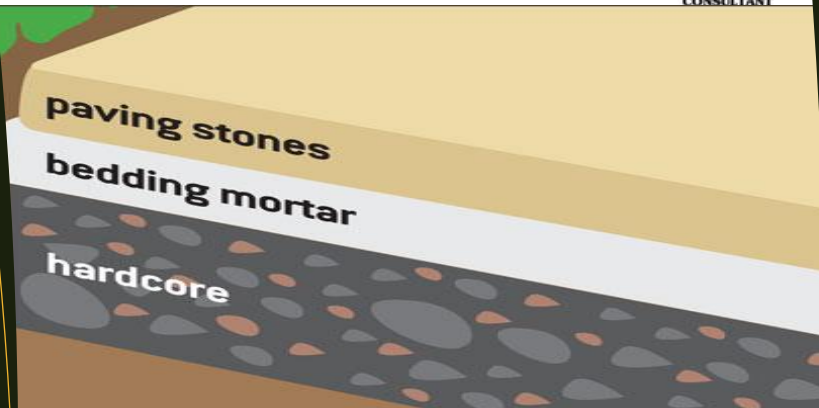
It is not uncommon for us to be instructed when communications between neighbours have irretrievably broken down. In this case damage was quite clearly being caused by a 14m tall Leyland Cypress only 1.4m from the main area of damage. The neighbour refused to accept the damage was attributable to their tree.

There is no British Standard on the form of construction of a patio. However, there is a widely accepted process and in this case the poor original construction of the patio had contributed to the ease with which the root damage had occurred.

Removal of the underlying surface roots was a possibility but following their exposure it was clear they provided structural support. We successfully negotiated a conclusion to the case by emphasising the significant growth potential and ongoing pruning costs to the tree owner if the tree remained.

The tree was removed and the patio repaired with the tree owners meeting that cost.
